REPORT ON
CONCRETE CORES EXTRACTED
FROM BOX CULVERT OF
PROVINCIAL HIGHWAY PROJECT
(CONTRACT PACKAGE # 5)

NTRC-216

May, 2000

MARDAN-SWABI, PROVINCIAL HIGHWAY PROJECT, CONTRACT PACKAGE # 5
 COMPRESSIVE STRENGTH AND DENSITY OF CORES

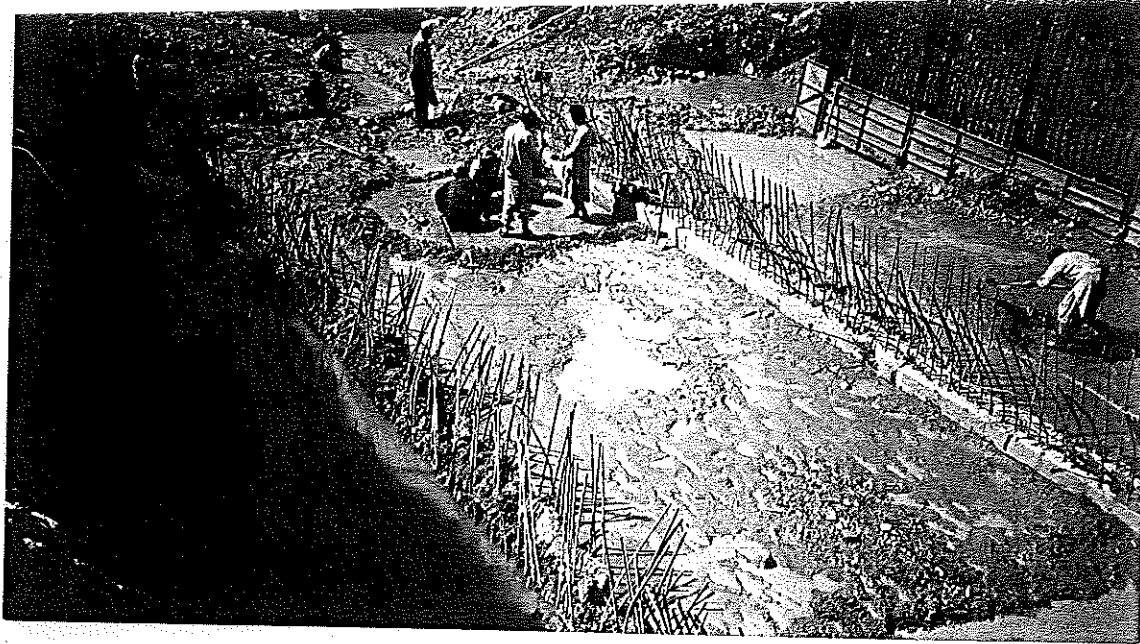
Photo.5.1: A General view of the site on 01-10-1998 at 11:00 am. The site was unsuitable for Coring works as can be seen. Upto two feet mud covered the base slab of the box culvert.

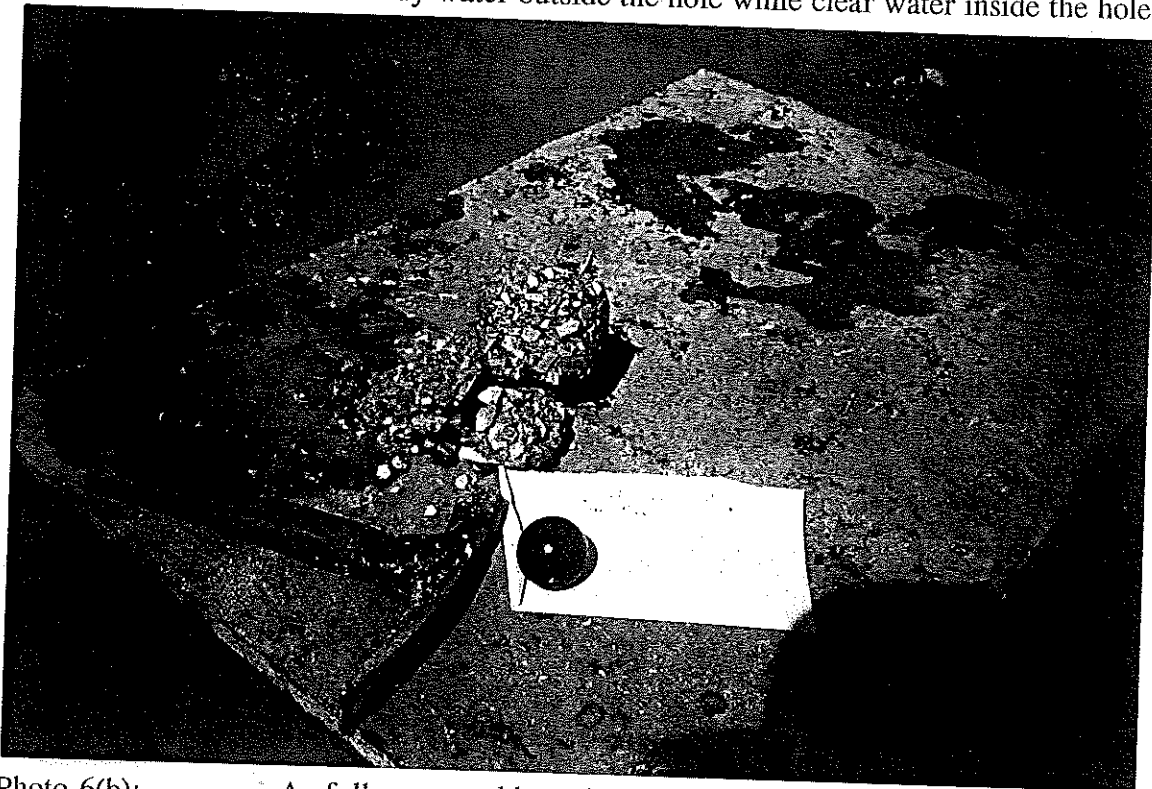
The dimensions of this core could not be recorded as a complete core could not be extracted. Only an irregular shaped specimen was extracted having a diameter of around 100 mm and a depth of around 100 mm. Further coring exercise just made a slush of concrete due to continuous disintegration of aggregates. The photographs 6(a) & (b) show the picture.

Photo.6(b): As full core could not be extracted and further coring resulted in disintegration of concrete, hence only slush material was removed.

Photographs No.6(a),(b) and 8(a),(b) show a very poor concrete, where mortar has been washed away and only coarse aggregates were locked into each other. The water was seeping into the hole at a fast rate. The location is shown on the attached map. The specimen showed significant signs of honeycombing due to washing away of cement mortar.

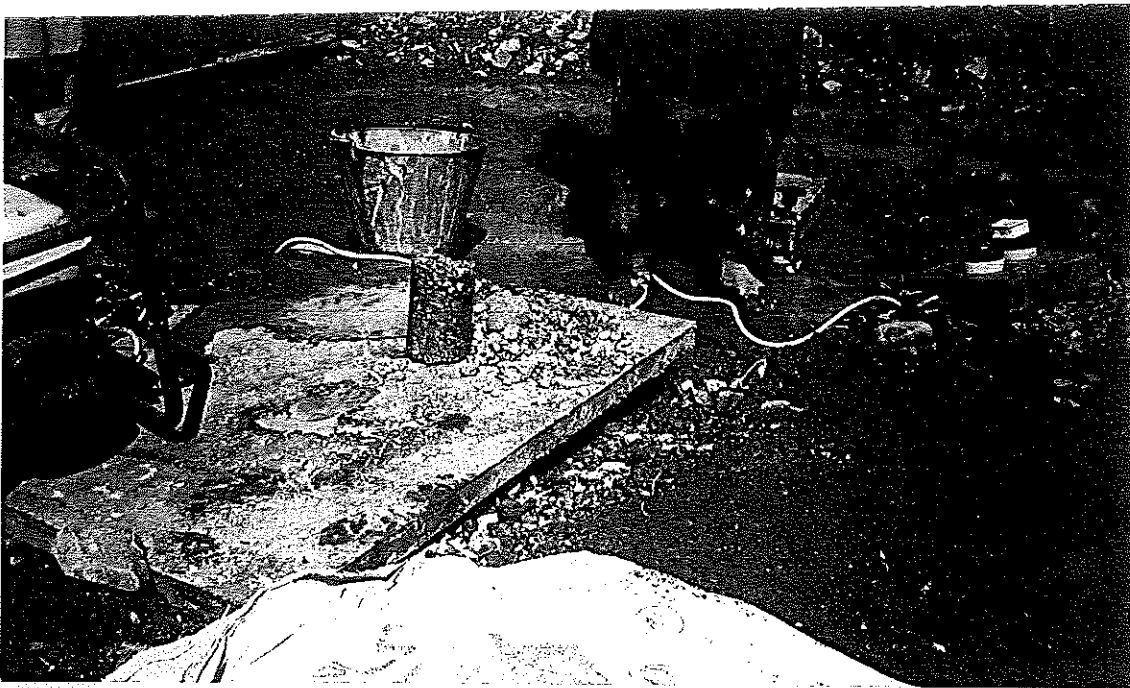
A core of 100 mm diameter and 150 mm depth was extracted below the clear cover level. The core was solid, having no signs of honeycombing and voids. But the later portion showed extensive honeycombing as no core can be extracted due to disintegration/collapsing of the core. It was observed that water was seeping into the hole at a fast rate. The photographs 7(a), 7(b) and 7(c) show the picture.

Photo.7 (a): Core 2 could only be drilled upto 150 mm below the clear cover level. Further coring works were abonded after disintegration of concrete *Core*.

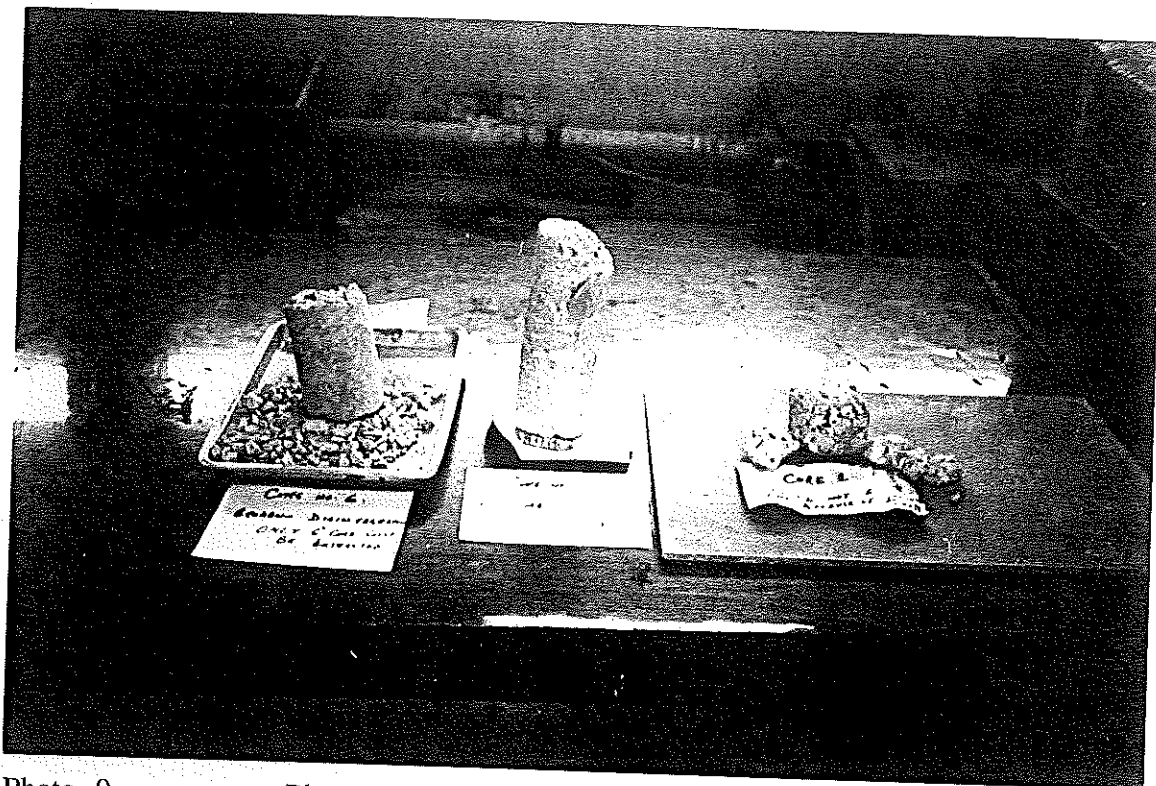
A full core of 100 mm diameter and 250 mm depth was extracted. Some voids were visible but no honeycombing area was visible and the core looked solid as shown in the laboratory pictures. No signs of water seeping into the hole were observed as against the case of cores No.1 and No.2.

Photo. 9: Photograph showing 1st row of cores, in order are (from right) core No.1, core No.3, core No.2.
